### **DESIGN, FABRICATION, AND ON-SITE ASSEMBLY OF A 350,000 GALLON FIBERGLASS POTABLE WATER TANK**

In August of 2003, Plasticos Industriales of Tampico, S.A. (PITSA) was contracted by Abbott Laboratories of Casa Grande, Arizona, to design and fabricate a 350,000 gallon capacity fiberglass rinse water tank that would be capable of handling over 1,000,000 gallons of potable water daily. Because of the size of the vessel (32'10"Ø x 55'3" side) wall in a seismic zone 2A and the requirement for the vessel to meet ASME RTP-1 and AWWA D120-02 design standards, detailed design calculations were required. The vessel also had to comply with FDA regulation 21CFR177.2420. The decision to use fiberglass as opposed to other construction materials was based on the understanding that the complete vessel would be made of non-corrosive materials, FDA-approved materials, and there would be no potential of contamination by rust as would be the case in coated mild steel vessels. The cost of a fiberglass vessel was less than that of a stainless steel vessel while still providing the FDA compliance required.

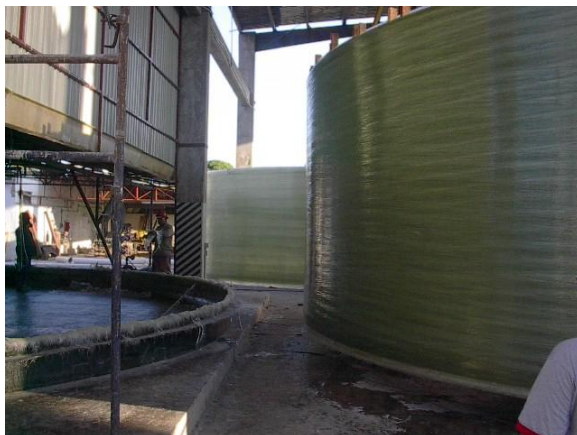
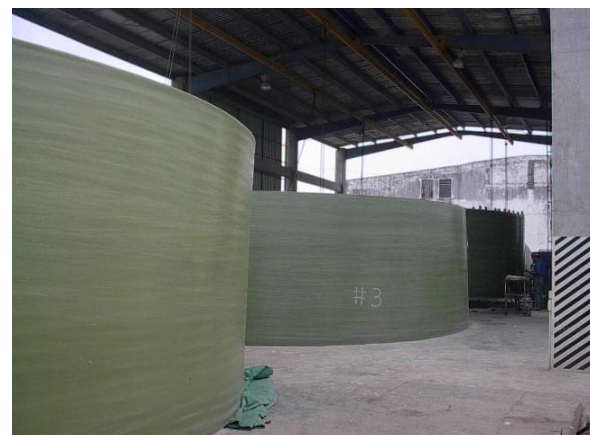
Shop fabrication of floor and wall sections of 350,000 gallon FRP tank

One of the advantages of fiberglass is that material thicknesses can be varied based on the loading required. Since higher stresses are seen toward the bottom wall of the tank and around vessel penetrations, the wall thickness started at 2.11” at the bottom knuckle and tapered down to .39” at the top of the vessel wall. All tie down, fabrication, and field assembly calculations were prepared based on the seismic loading requirements in conjunction with the ASME RTP-1 and AWWA D120-02 standards.

As the vessel sections were completed at the plant, the sections were post-cured with dry heat at 200°F for two hours. Final steam cure of the completed vessel would be performed on site. Extensive testing of raw materials was carried out, and records were maintained of all raw materials and in process fabrication inspections in accordance with ASME RTP-1 standards.

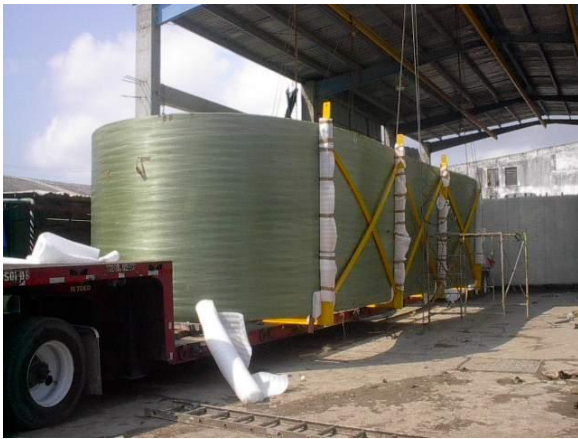
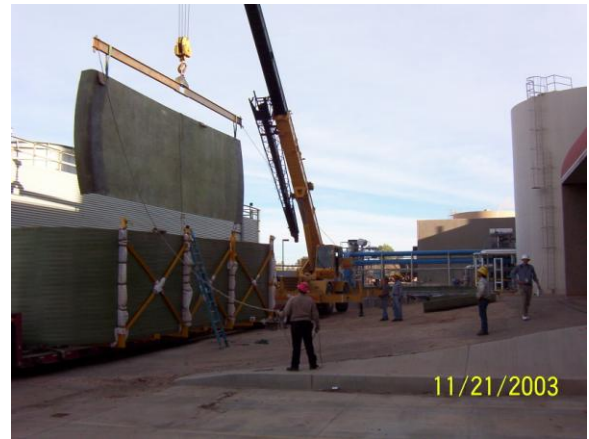
Walls are oblated and the vessel sections are shipped to Casa Grande, Arizona

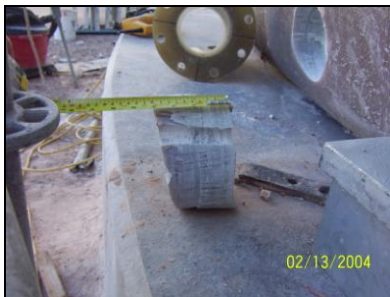
Bottom knuckle

Once the sections were offloaded, the process of field assembly was begun by C&E Industrial Services out of El Paso, Texas under the supervision of PITSA personnel. With the bottom knuckle being 2.11" thick and the bond between the bottom knuckle and the first wall section being 2.4" thick, bonding of the vessel sections was time consuming. Care had to be taken to ensure that there was no air entrapment in the layers, and that the laminates were allowed to exotherm slowly to avoid damage to the bond.

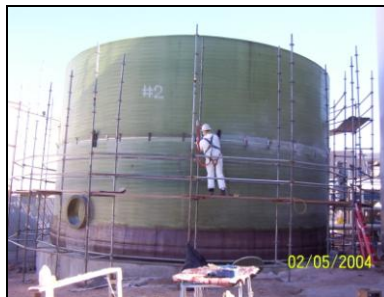
Assembly of lower sections

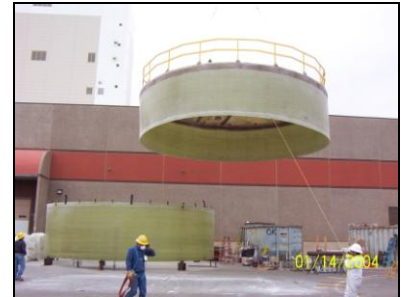
Setting top section with handrail

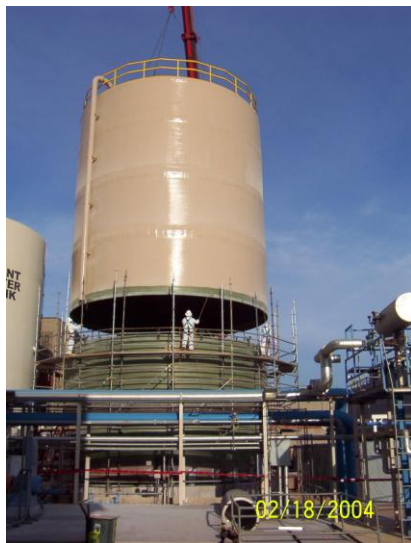
Setting upper sections on lower sections

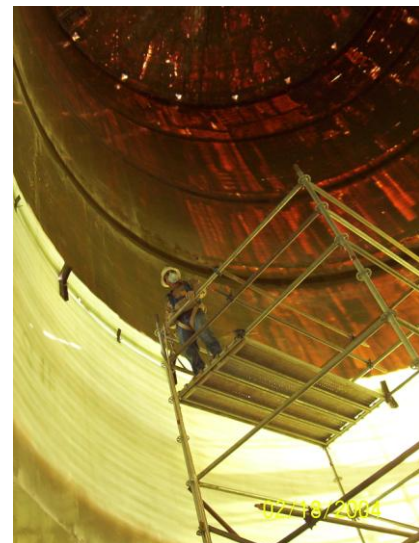
Interior seams applied & inspected

As the exterior bonds were being made and rings assembled, the internal corrosion barrier at the seams was also applied and inspected.

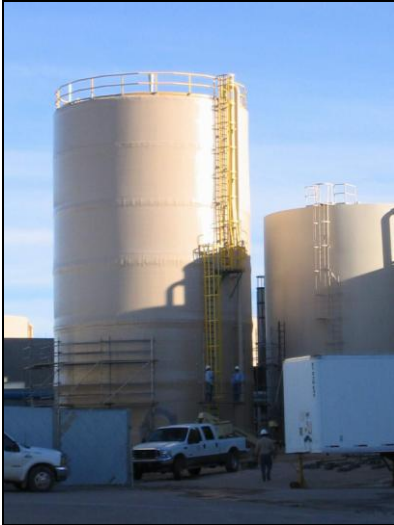
Completed 350,000 gallon tank

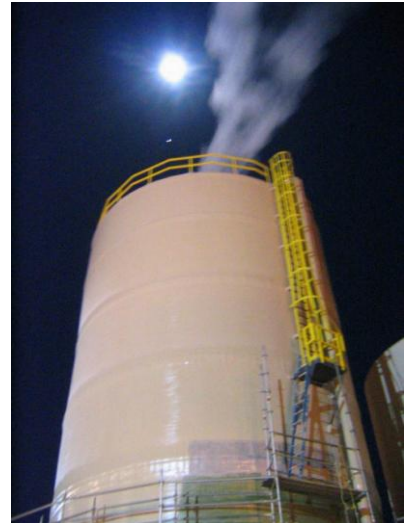
16 hour steam cure at 160-180°F

When the lamination was complete, the walls were washed with a high pressure washer, and a final inspection of the laminates and accessories was carried out. The next step was to perform the final steam cure which required raising the interior temperature of the vessel to a minimum of 160°F for a period of 16 hours using high pressure steam. With a vessel of this size, special steam distributors needed to be constructed, with care to ensure the safety of personnel carrying out the post cure.
